NASA TECHNICAL
MEMORANDUM

NASA TM X-64844

MSFC SKYLAB NEUTRAL BUOYANCY SIMULATOR

14. SPONSORING AGENCY CODE	
15. SUPPLEMENTARY NOTES					
16. ABSTRACT Presented in this report is the role of the Neutral Buoyancy Simulator in the development, crew training, and flight operational aspects of Skylab.

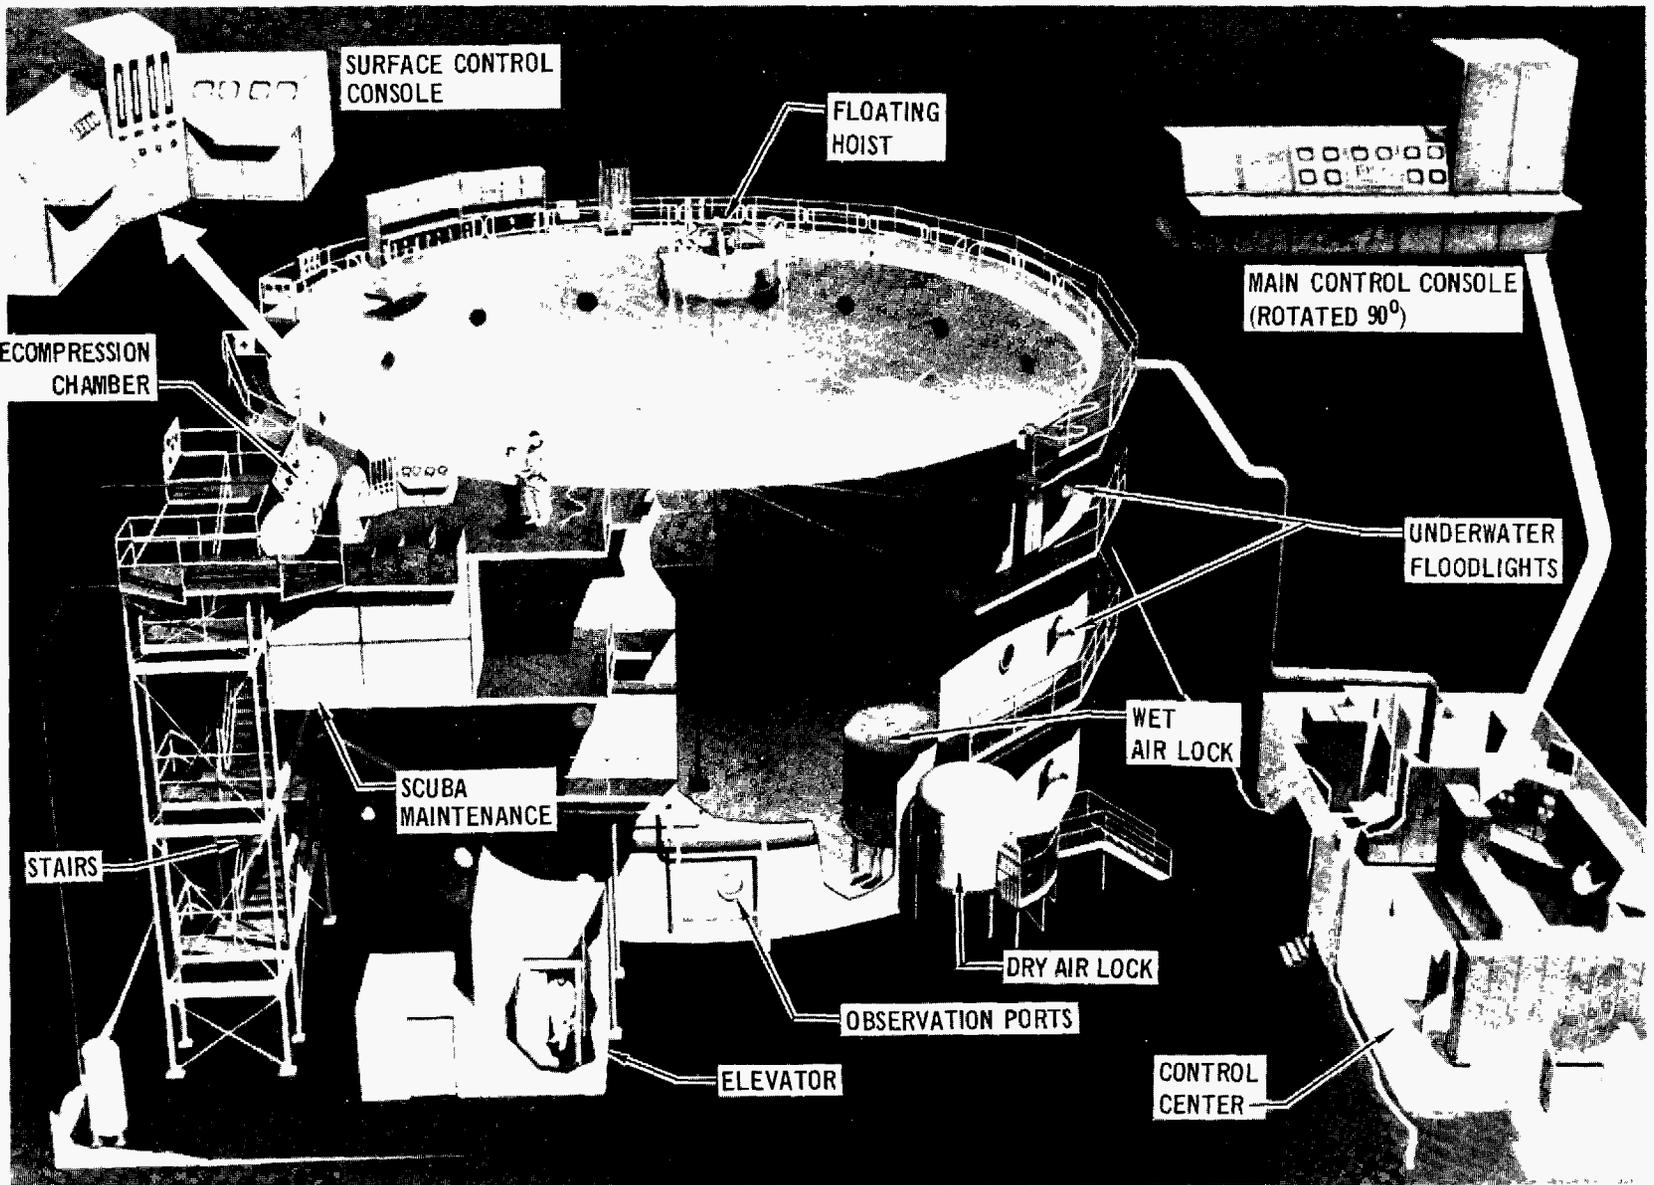
FIGURE 1-1 NEUTRAL BUOYANCY SIMULATOR

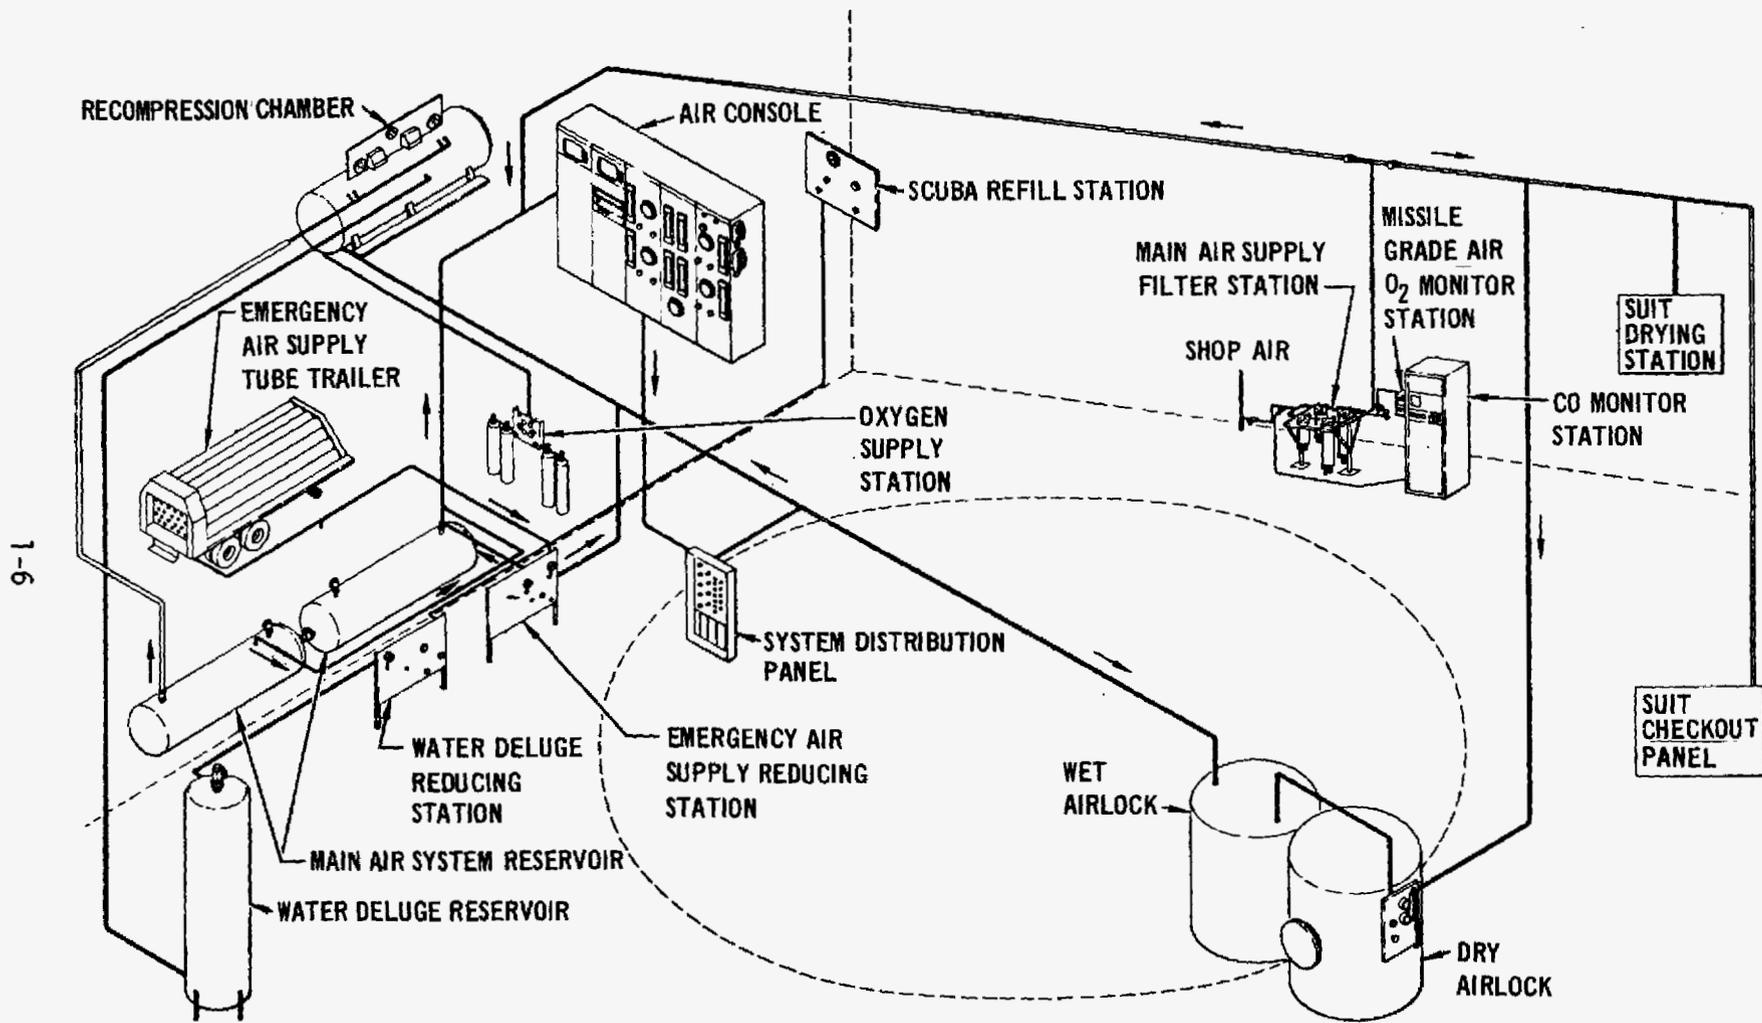
FIGURE 1-3 NBS AIR DISTRIBUTION SYSTEM

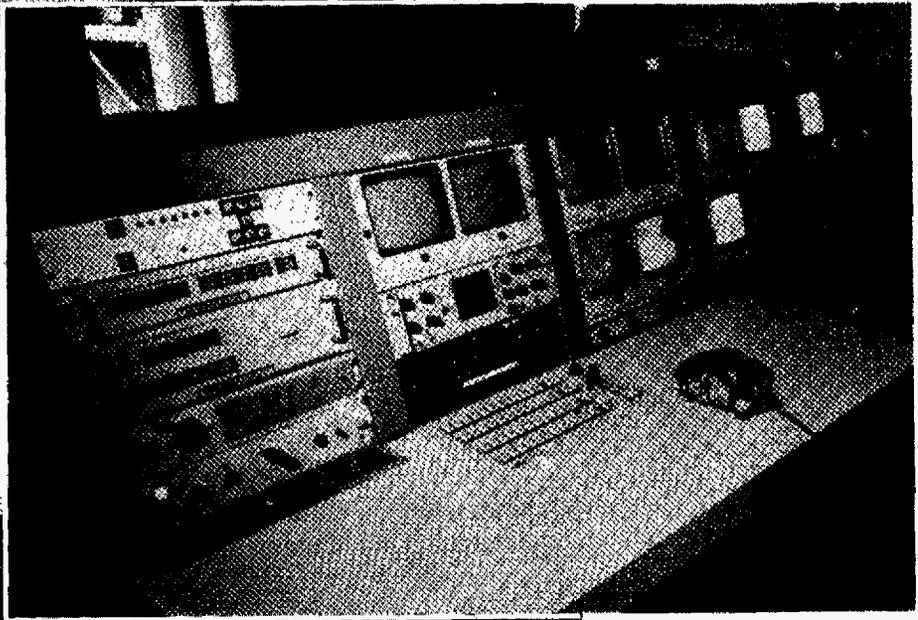
FIGURE 1-6 MAIN CONTROL CONSOLE AND VIDEO TAPE RECORDER

video, audio, EKG, heart rate, LCG flow, LCG inlet temp, LCG outlet temp, air flow to suit, inlet air temp, outlet air temp, respiration rate, differential suit pressure, depth pressure, absolute suit pressure, etc. The signal conditioning equipment, meters, and pressure suit junction panels are located at the tank with the instrumentation monitoring and recording equipment located in the test control center. Inside the water tank during an NBS exercise, there are nine remotely controlled TV cameras, a mobile underwater color video swim cameraman, an underwater photographer, and an underwater speaker system. A remotely controlled video camera is located on top of the tank along with test consoles containing video monitors. The video system has black and white or color recording and playback capability.

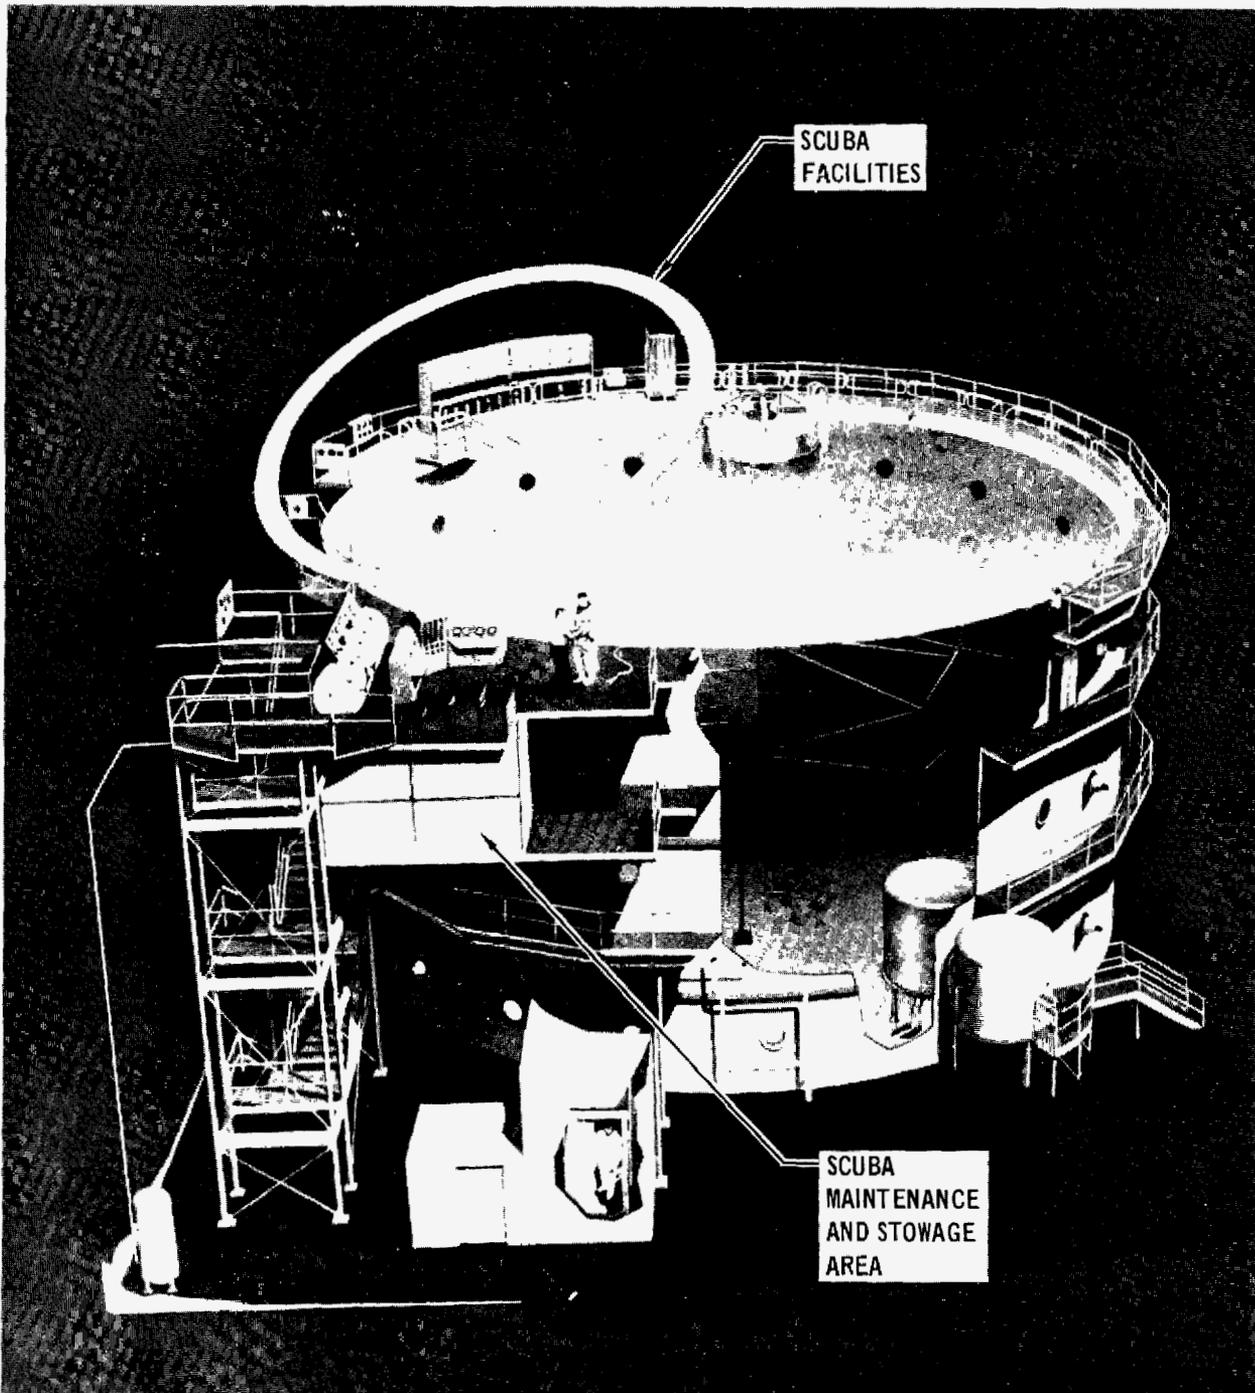
FIGURE 1-7 NBS SCUBA SUPPORT FACILITIES

Facilities to support SCUBA operations (SCUBA tanks, wet suits, fins, cylinder refill station, etc.) are located on top-side of the tank (Figure 1-7). The SCUBA refill station consists of a panel containing supply, delivery, and SCUBA cylinder pressure gauges with delivery and vent valves (Figure 1-8). The high pressure air (2,250 psi max) is

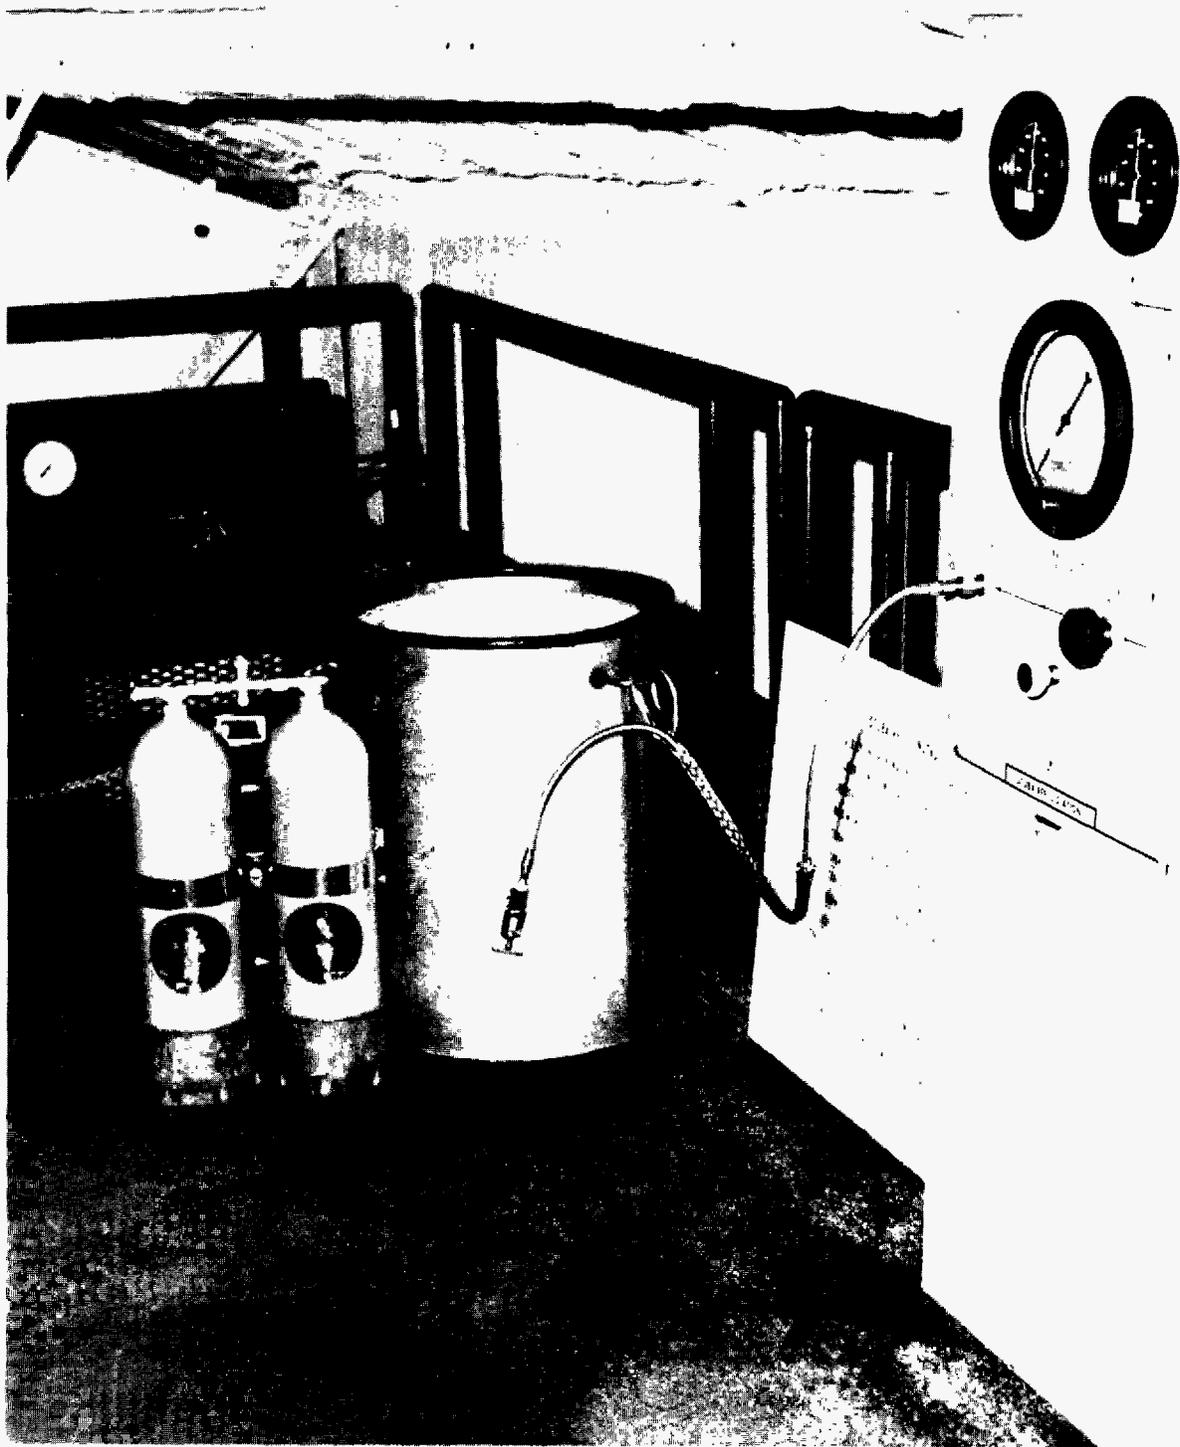
FIGURE 1-8 SCUBA REFILL STATION

supplied from the emergency air supply tube trailer. A flow diagram on the panel aids the user in refill operations. Refill operating procedures are also printed along side the refill panel. The SCUBA cylinders are submerged in a water container during refills as a safety measure. The water serves as a heat sink during pressurization and provides a protective barrier in case the SCUBA cylinder ruptures.

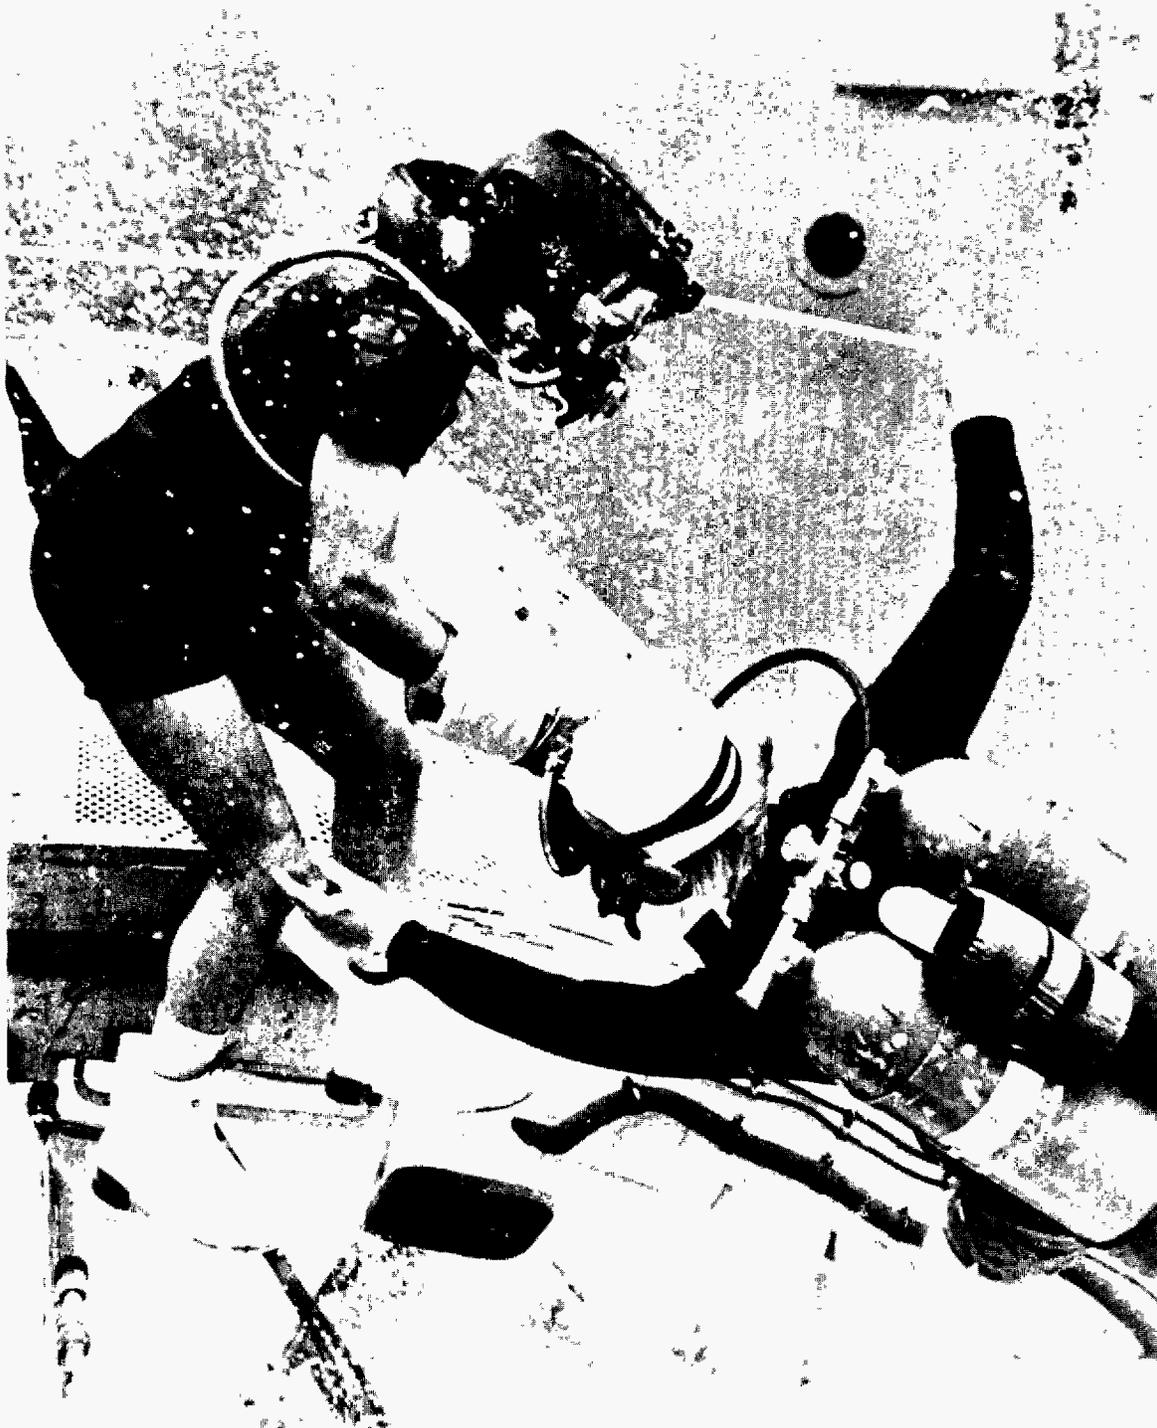
FIGURE 1-11 PRELIMINARY EVALUATION EXERCISE USING KIRBY-MORGAN HELMET

Quite often it was beneficial to perform a preliminary suited exercise evaluation using the Kirby-Morgan head piece. The Kirby-Morgan helmet seals around the face and is equipped with viewing glass, breathing regulator, and a single umbilical that provides breathing air and communications (Figure 1-11). Neutral buoyancy is achieved by a weighted belt. EVA gloves and boots could be worn to make the preliminary evaluation more realistic in terms of what could or could not be accomplished in an EVA task situation. Using the Kirby-Morgan helmet provided the capability to perform a quick cursory review of hardware orientation and EVA tasks with a minimum impact on NBS systems and personnel. In addition, use of the Kirby-Morgan was more effective than use of SCUBA diving equipment because of the two-way communication capability and absence of bulky air cylinders.

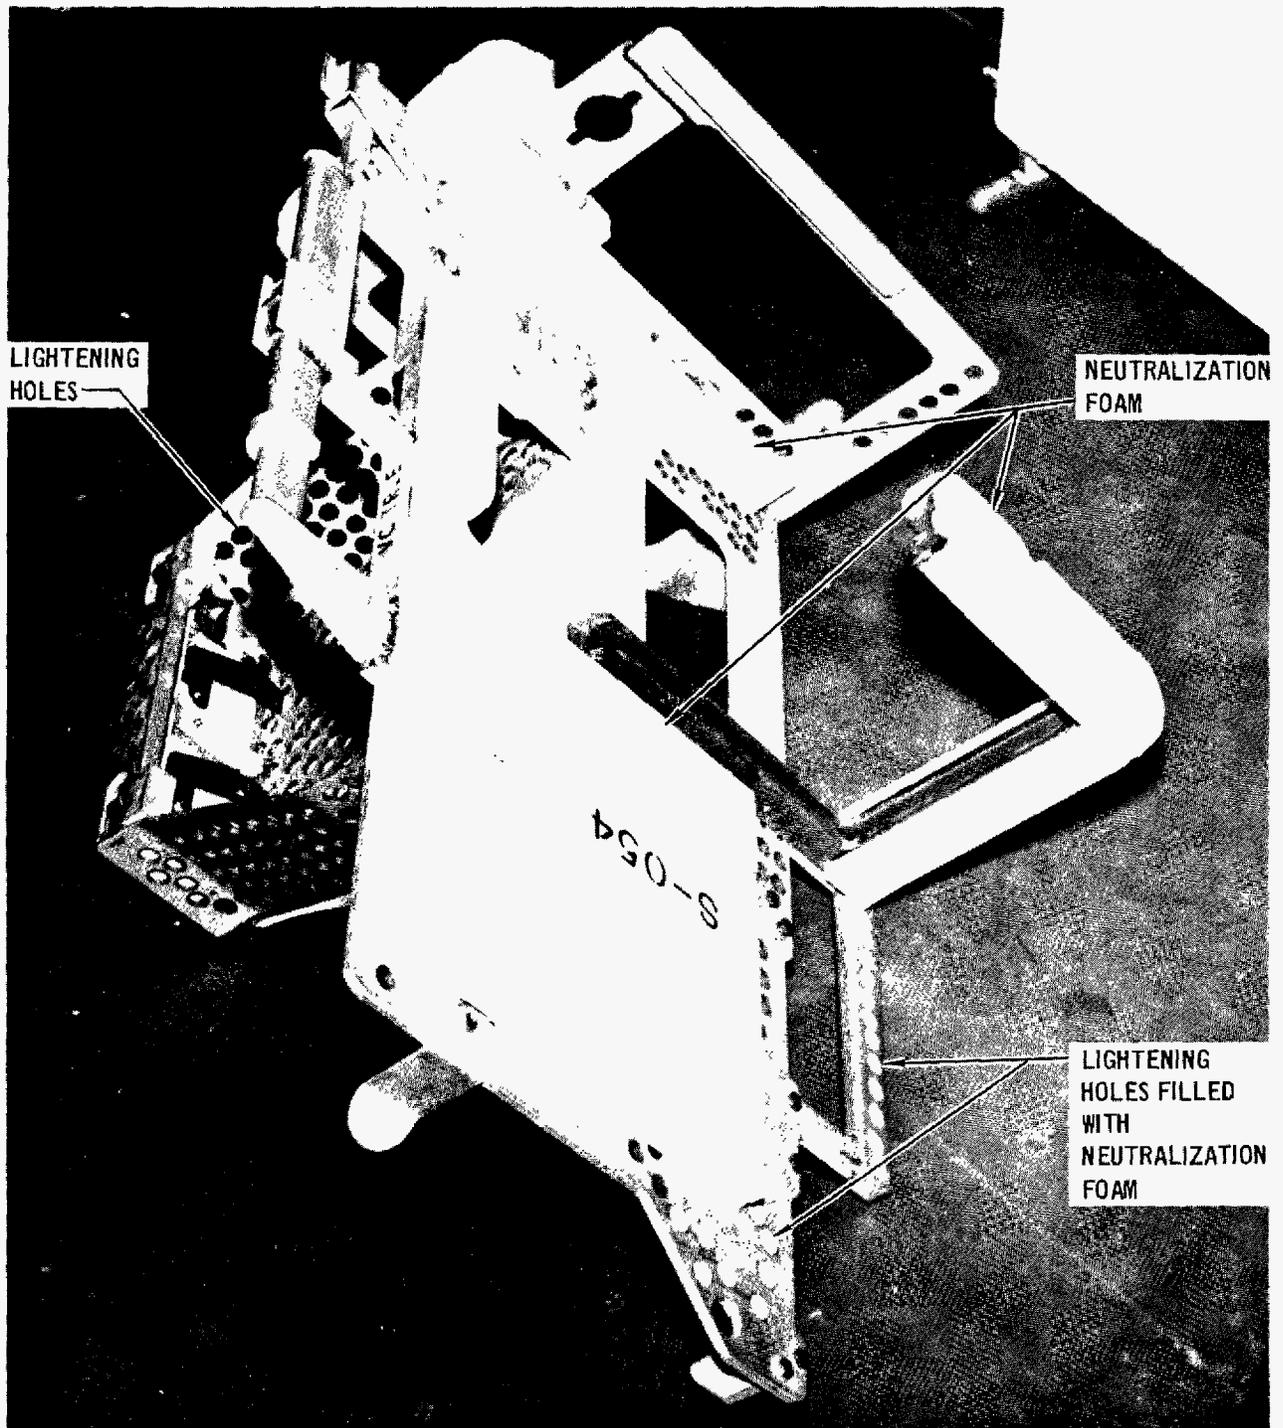
FIGURE 1-12 NEUTRALIZED VC ATM FILM TREE

To make equipment neutrally buoyant, flotation units are installed inside the hardware and located so the equipment retains its original center of gravity (CG) (Figure 1-12). Additionally, flotation units must be strategically located so they will not interfere with equipment mechanism operation or disturb the equipment envelope. Also, the flotation units must not change due to changes in water pressure, or the neutral buoyancy will be lost. Location and volume of the flotation units are calculated and temporarily installed so the unit can be "trimmed out" underwater by SCUBA divers. CPR-200-8 styrofoam with

6-8 lb/cu ft density was found to be the best material for flotation units. It was easily shaped to obtain the desired volume for neutral buoyancy and was easy to install. After shaping, and prior to final installation, it was coated with epoxy resin (Crest 3135) to prevent water absorption.

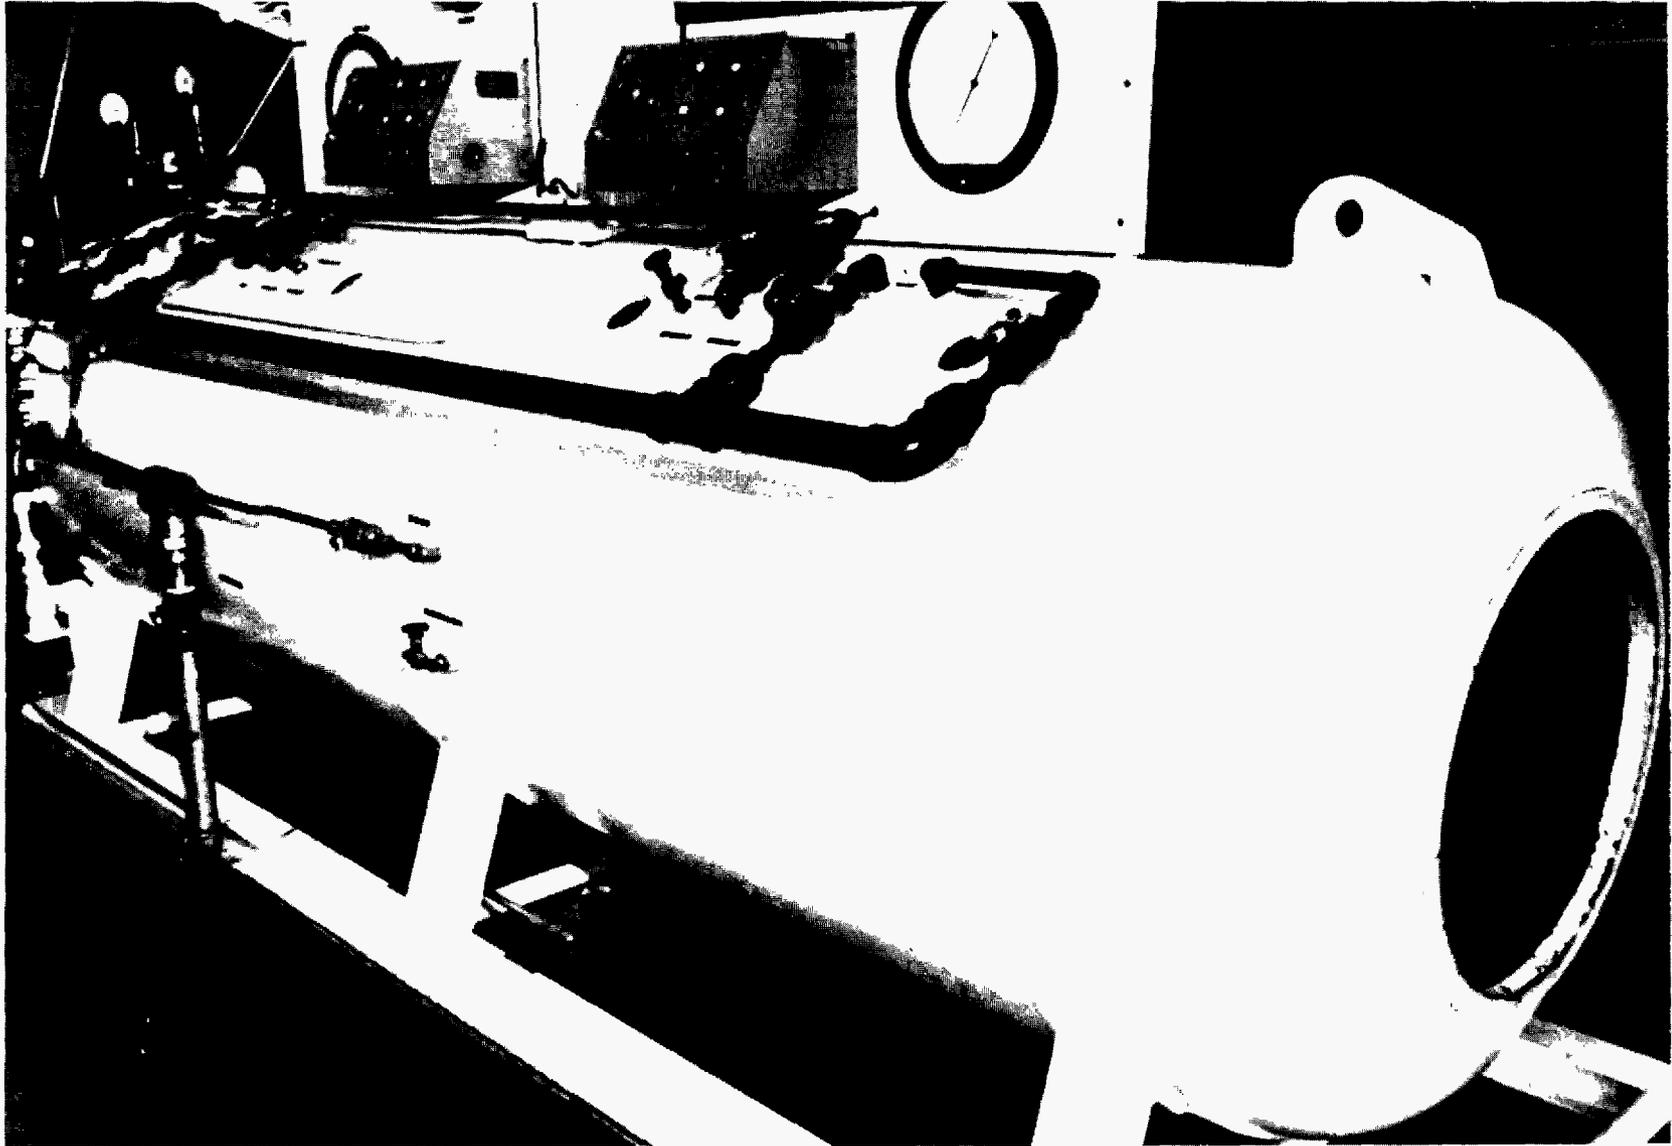
FIGURE 1-13 RECOMPRESSION CHAMBER

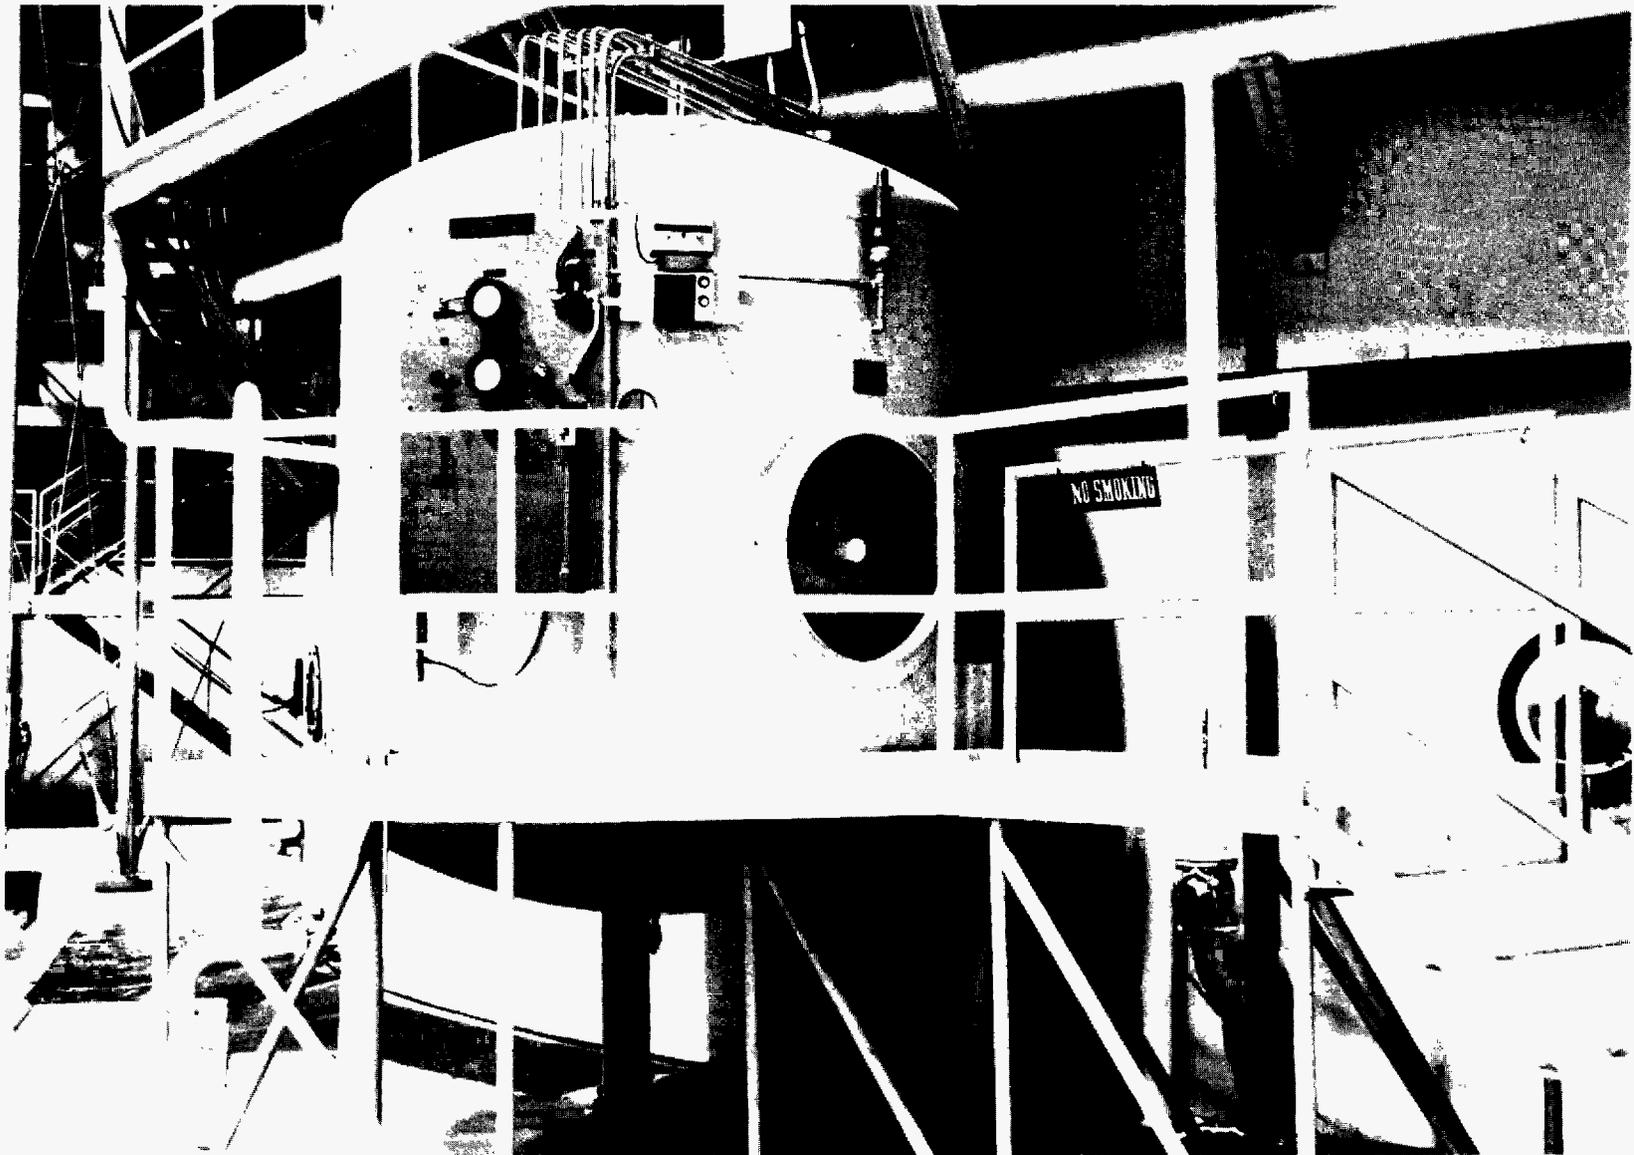
FIGURE 1-14 DRY AIRLOCK

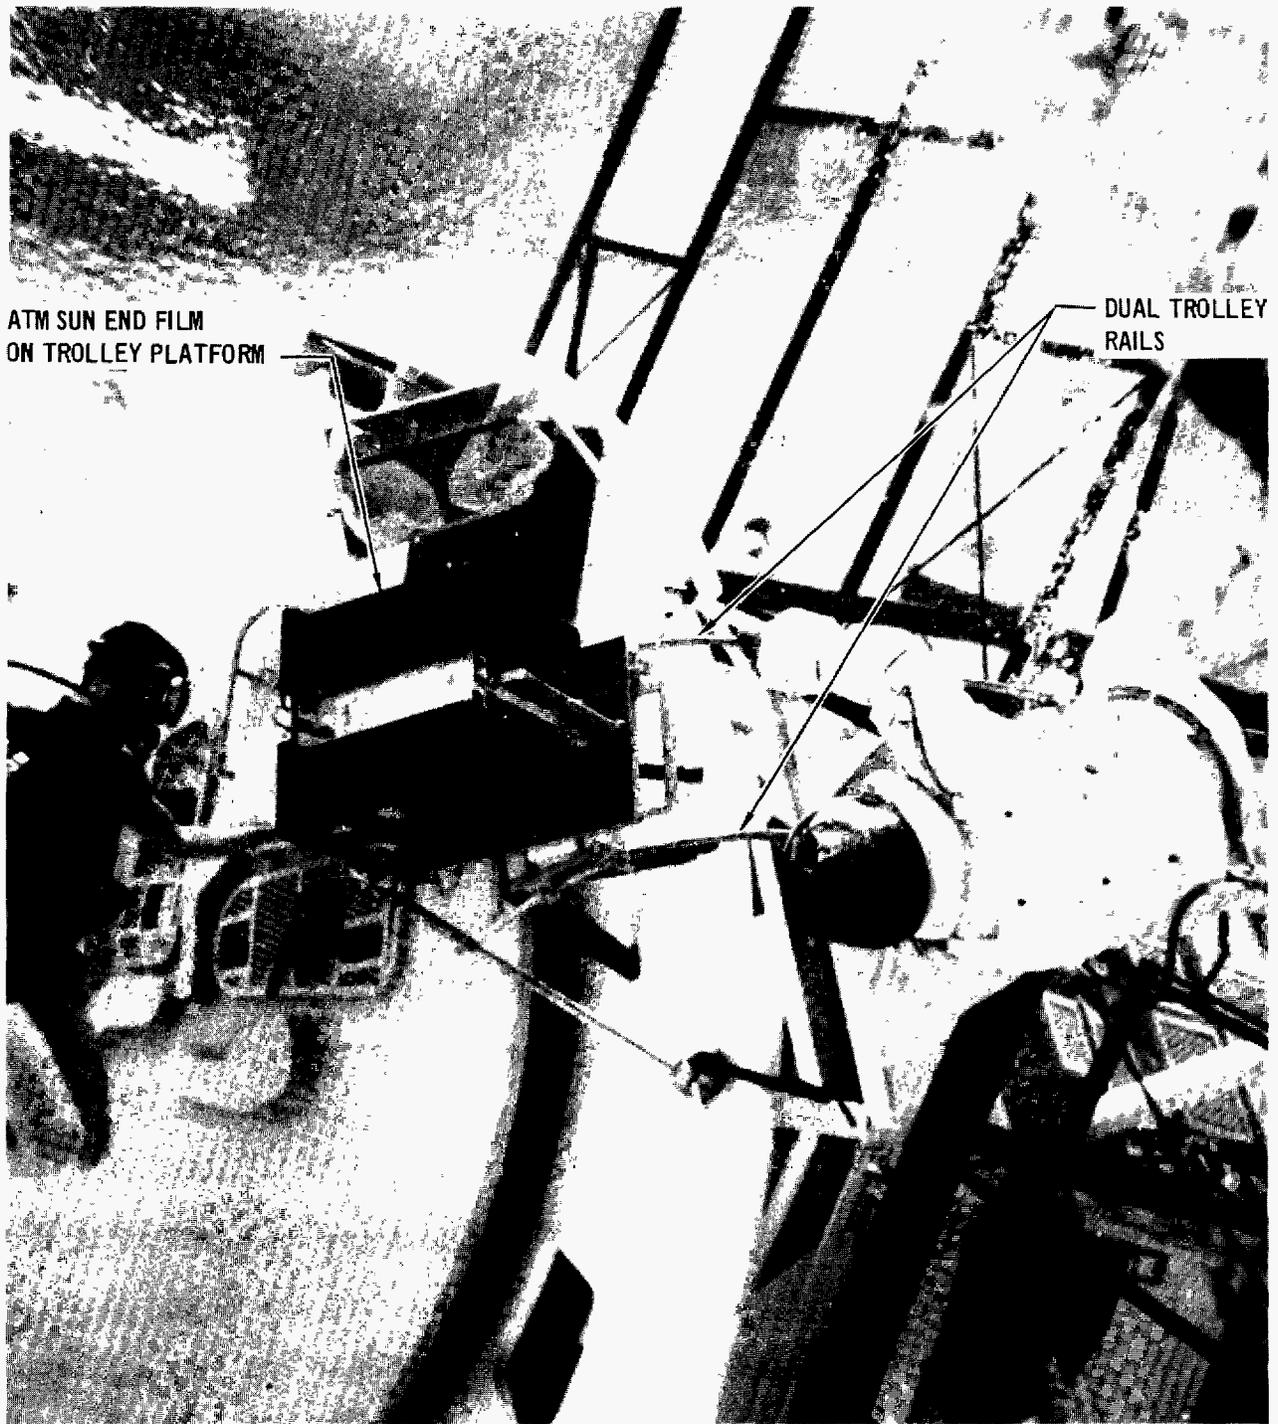
**FIGURE 2-1 TRANSLATION OF ATM FILM TO SUN END WORKSTATION
USING PRELIMINARY "TROLLEY" CONCEPT**

- o Early Skylab NBS evaluations revealed that a translation device was required to move the ATM film between FAS and ATM workstations.
- o One concept was to attach the ATM film to a trolley platform that was connected to a pair of rails extending from the DA to the ATM Sun End(Figure 2-1). The crewman would push the film trolley in front of him as he translated along the dual rails. This concept was tried and proved more complex than methods later developed.

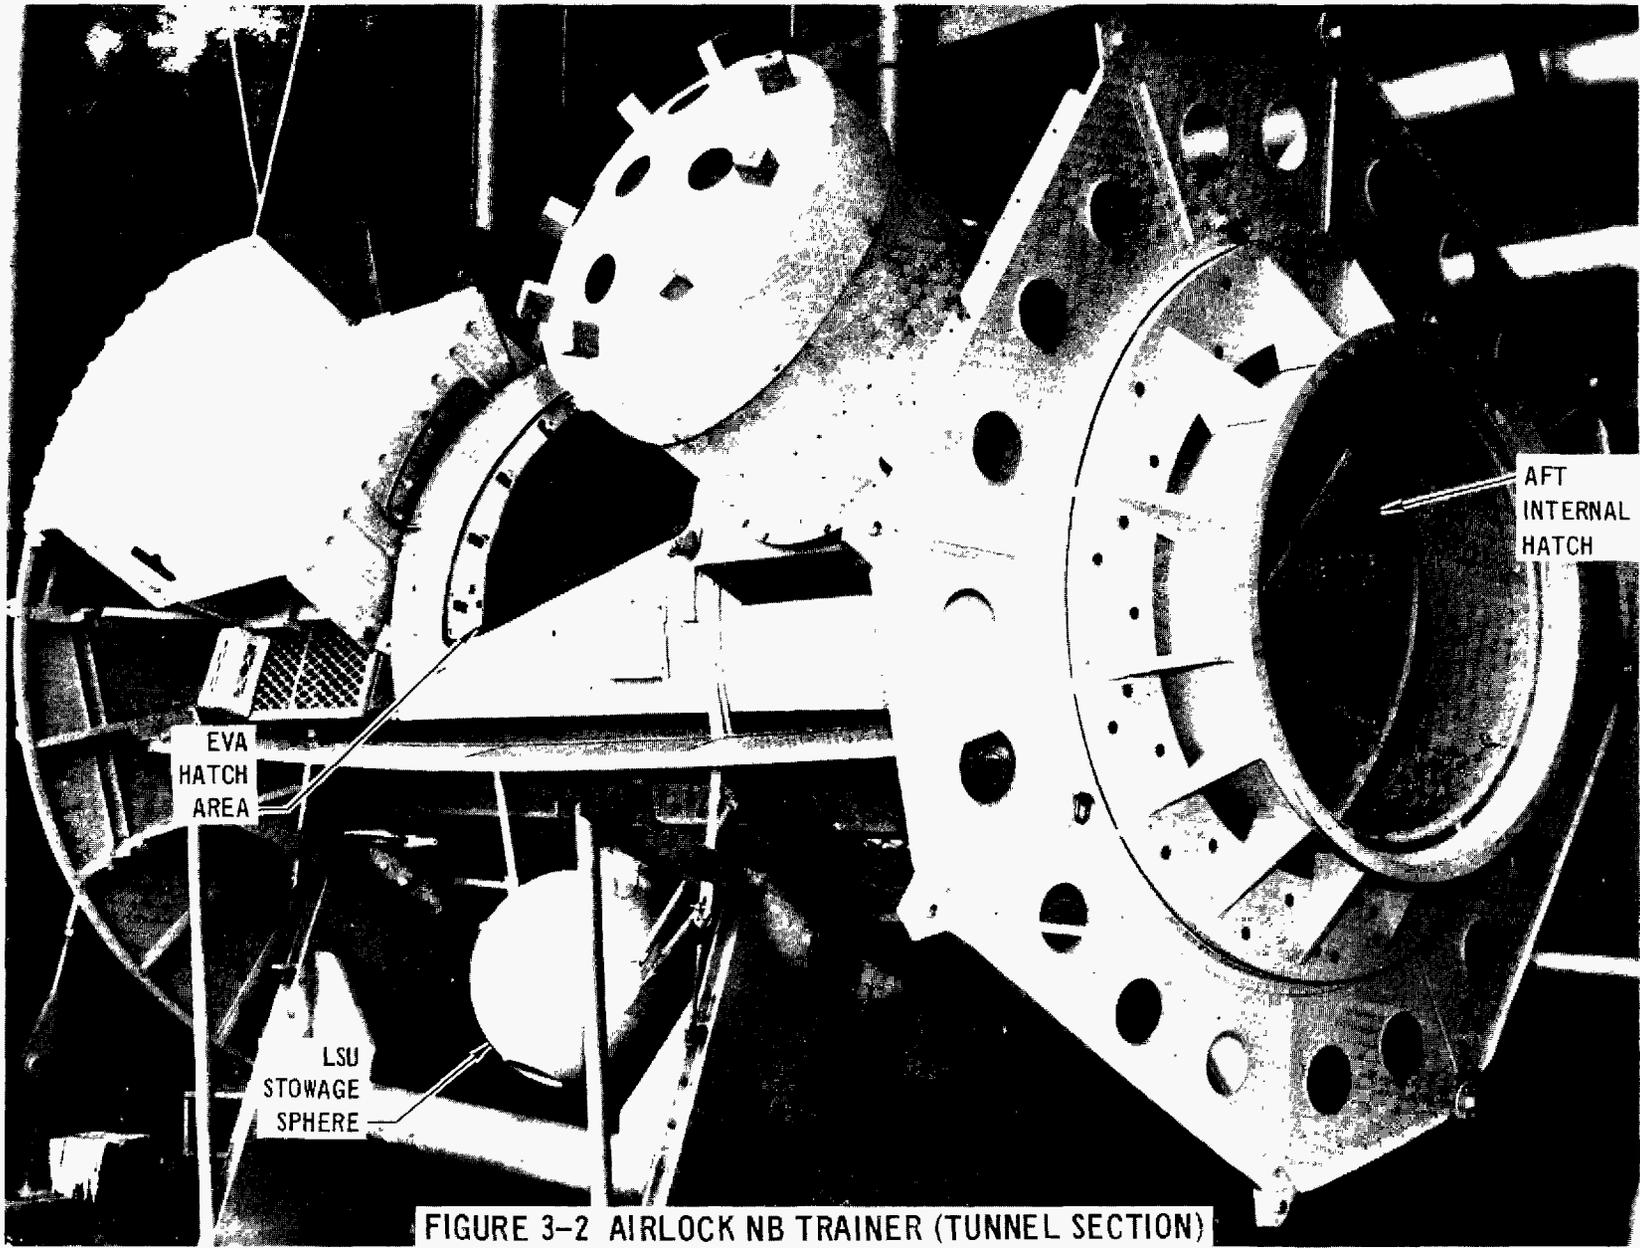
FIGURE 3-2 AIRLOCK NB TRAINER (TUNNEL SECTION)

rings and channels, riveted to the skins. Original skins were expanded metal 3003-H14 aluminum .003m (.12 in.) thick; these were later replaced with solid 2024-T3 aluminum rolled sheets. Truss structure was .1m (4.0 in.) square 6061-T6 tubing with smaller diameter structural 6061-T6 aluminum tubing welded. See Figures (3-2, 3-3, 3-4, and 3-5).

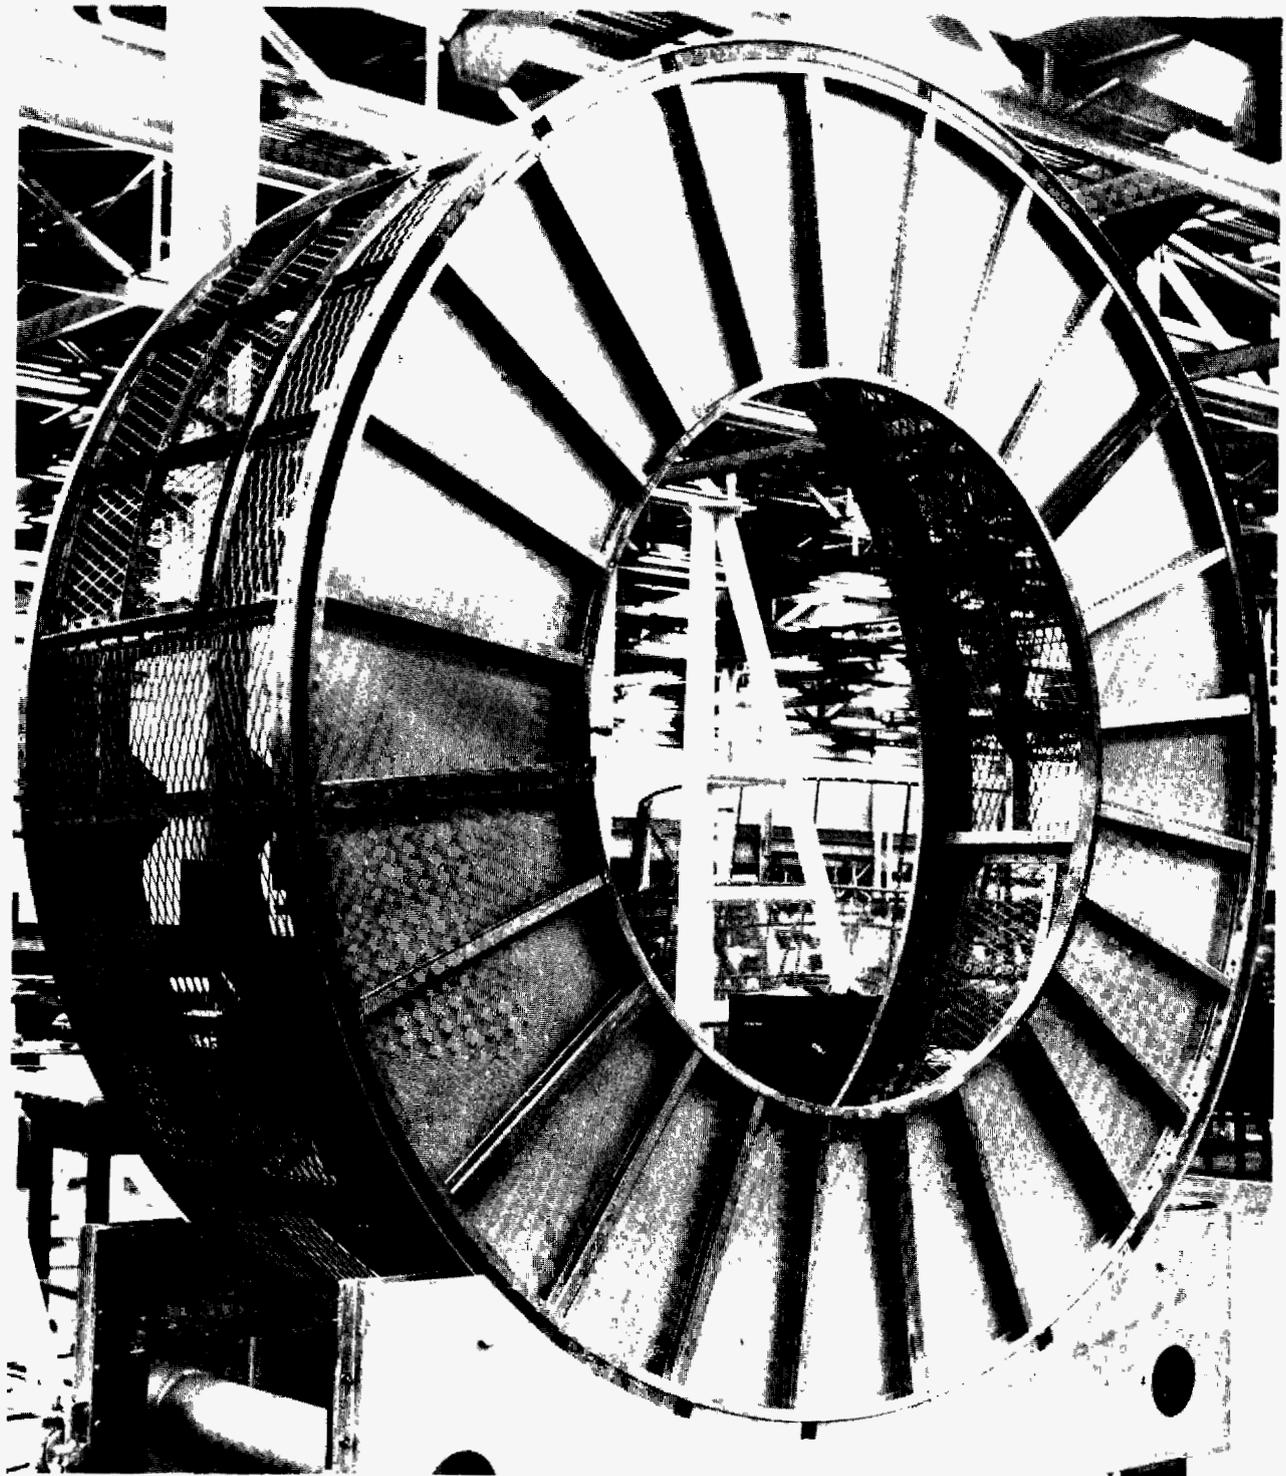
FIGURE 3-3 AIRLOCK STRUCTURAL TRANSITION SECTION (STS) NB TRAINER
